# Dynamic investigation on the Mirandola bell tower in post-earthquake scenarios

**Abstract** After the seismic events of the 20th and 29th of May 2012 in Emilia (Italy), most of the monumental and historic buildings of the area were severely damaged. In a few structures, partial collapse mechanisms were observed (e.g. façade tilting, out-of-plane overturning of panels...). This paper presents the case-study of the bell tower of the Santa Maria Maggiore cathedral, located in Mirandola (Italy). The dynamic response of the structure was evaluated through operational modal analysis using ambient vibrations, a consolidated non-destructive procedure that estimates the dynamic parameters of the bell-tower. The dynamic tests were carried out in pre-intervention and post-intervention conditions in order to understand the sensitivity of dynamic measurements to safety interventions. Furthermore, a comparative study is made with similar cases of undamaged masonry towers up to the 6th mode. Finally, an investigation on the state of connections and of the building itself is carried out via FE model updating.

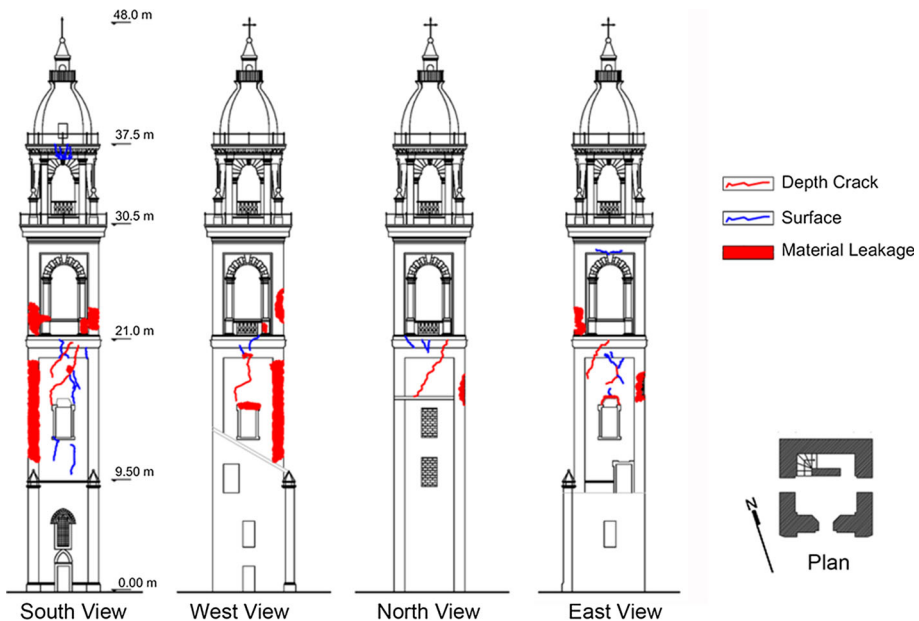
The May 2012 Emilia earthquake sequence severely damaged the cathedral, with two events on May 20th and 29th. The epicentre of the May 29th event was less than 1 km far from the site of the bell tower, which led to massive destruction to the historical city centre of Mirandola. It resulted in the collapse of the aisle, the side aisle, the roof and in several cracks on the bell-tower (Fig. 2).

An exterior laser scanner survey of the cracking patterns, carried out by the INGV (Istituto Nazionale di Geofisica e Vulcanologia) within the ILRIS 3D project (Pesci et al. 2012), highlighted the activation of a twisting mechanism leading to a rotation of about 1 degree of the building portion located between 20 and 32 m. The structural damages are mainly concentrated in this section of the bell tower, where deep diagonal cracks right below the first order of openings on all four sides can be noted, extending down to the openings of the underlying level. Furthermore, various lintels failed on the South, West and East fronts. The twisting mechanism and the high local stresses caused the crushing of masonry near the area of the tower in contact with the adjacent building, especially at the

**Fig. 2** Post-earthquake damage survey of the Mirandola bell-tower

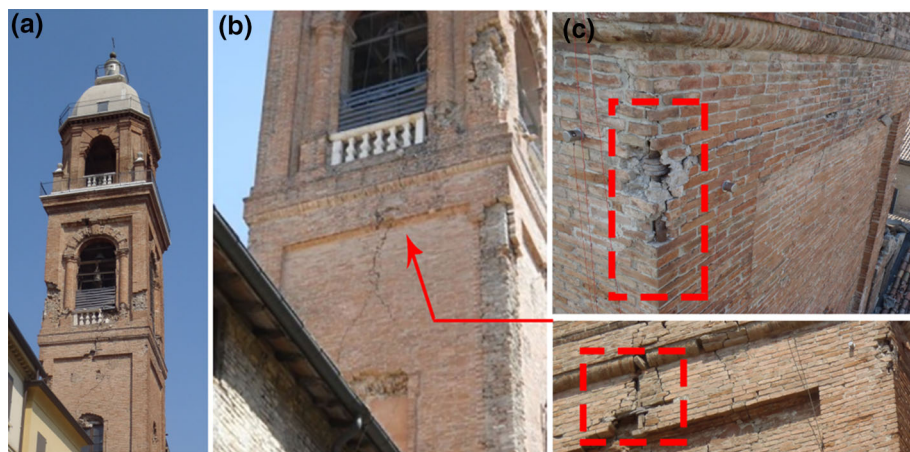
height of 21 m (Fig. 3a, b). Metal chains were revealed by the occurred damages inside the masonry layer around the perimeter at the base of this level of the structure, as shown in (Fig. 3c). The visual and laser scanner surveys did not confirm for the other levels.

**Fig. 3** Damage at the level of the belfry of the bell-tower (a, b) and the metal chains (c) at 20 m
